432 INSPECTIONS LLC

1234 Main Street  
Denver CO 80210

10/14/2026 9:00AM

# PROPERTY INSPECTION REPORT FORM

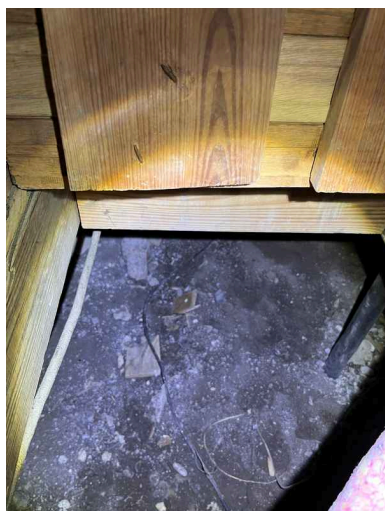
Crawlspace Access Hatch

Crawlspace observation was performed strictly from the access hatch opening due to inadequate vertical clearance (less than 18 inches). Inaccessible sub-floor framing, foundation piers, under-slab plumbing, and soil moisture conditions could not be visually verified.

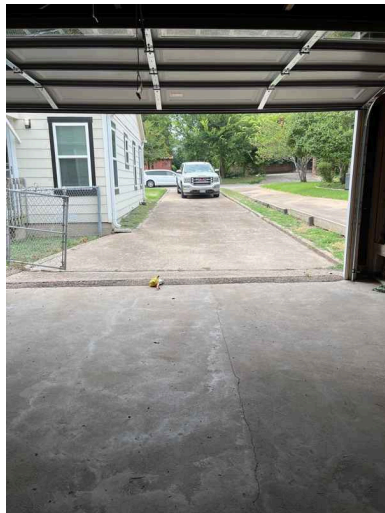
Perimeter & Garage Entry

Ground grade slopes toward the exterior foundation along the perimeter and toward the garage vehicle door rather than sloping away. Negative grading causes surface runoff to pool against the foundation walls, increasing the risk of structural settlement, slab movement, and water intrusion into the garage.

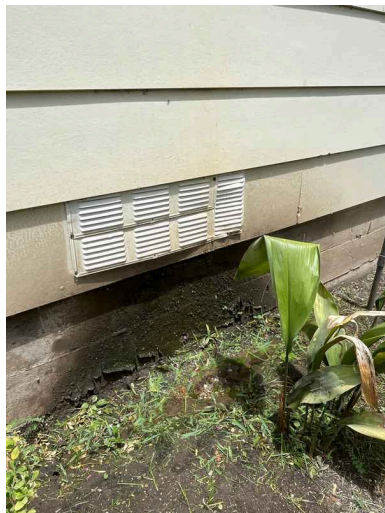
## 2: Standing Water

The primary HVAC condensate line discharges directly adjacent to the exterior foundation, resulting in persistent standing water and localized soil saturation. This promotes uneven foundation movement, wall moisture intrusion, and exterior cladding decay.

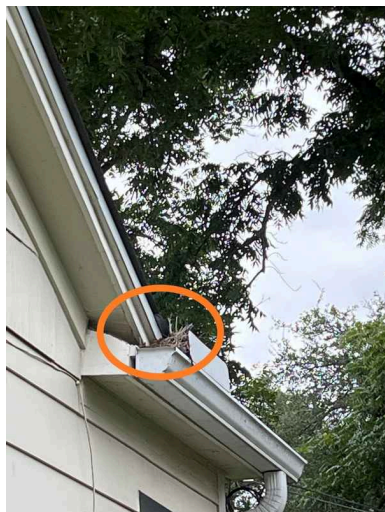
## 3: Clogged Gutter

Gutters are heavily obstructed with tree debris. Clogged gutters prevent proper water drainage away from the foundation, which can lead to water damage, soil erosion and foundation issues. Regular cleaning and maintenance are needed to keep gutters functioning properly.

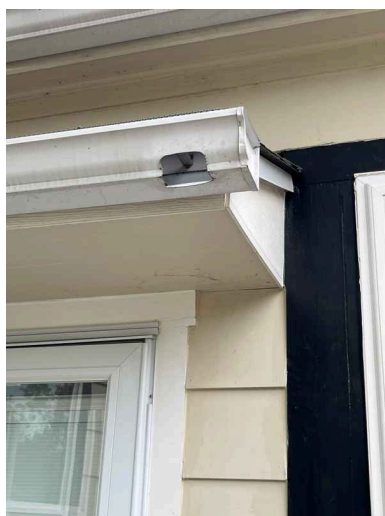
#### 4: Downspout is missing, damaged, disconnected, or has insufficient extension

Downspout is missing, damaged, disconnected, or has insufficient extension to direct water away from the house. This allows water to pool near the foundation, potentially causing soil erosion, water intrusion, and foundation damage. Have a gutter contractor inspect and repair or replace the downspout system with proper extension to direct water at least 4-6 feet from the foundation.

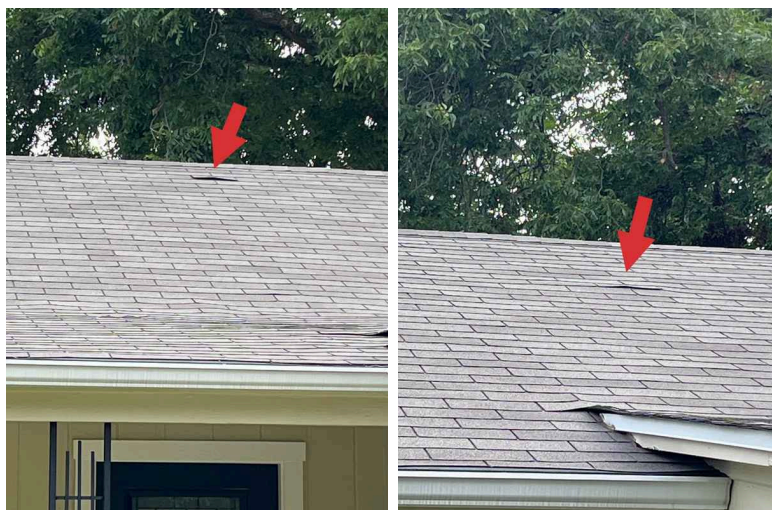
#### 1: Damaged Roof Coverings

Asphalt shingles exhibit advanced weathering, surface cupping, and curling along multiple roof planes. Cupped and brittle shingles have lost adhesive seal integrity and are vulnerable to wind uplift and wind-driven rain penetration.

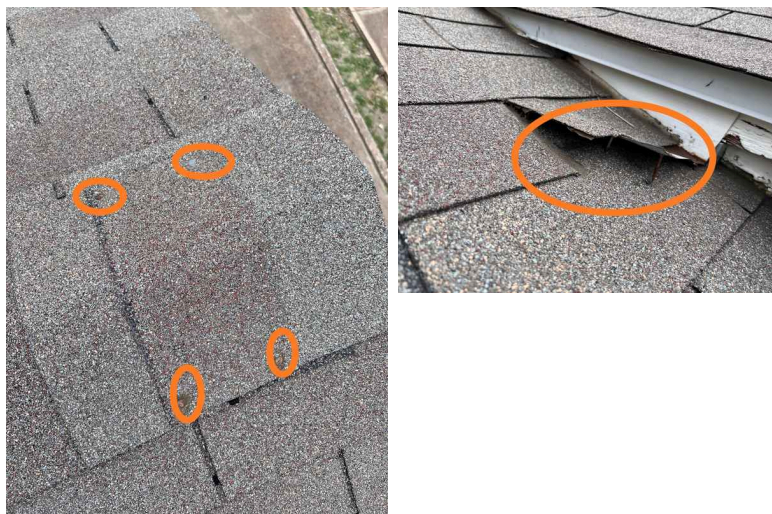
## 2: Popped/Exposed Nail in Roof Covering

Unsealed, exposed, and backed-out nail heads were observed through shingle surfaces. Exposed fasteners create direct penetration points for water intrusion into the underlying roof decking.

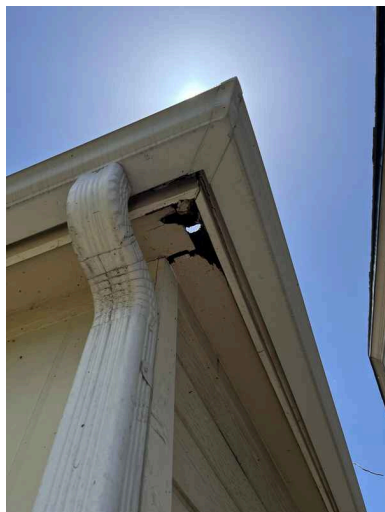
## 3: Damaged Roof Components

Damage was observed to roof components including eaves, fascia, and soffit during inspection. Deteriorated or compromised roof trim can allow water infiltration into the structure, potentially causing rot, mold, and structural damage.

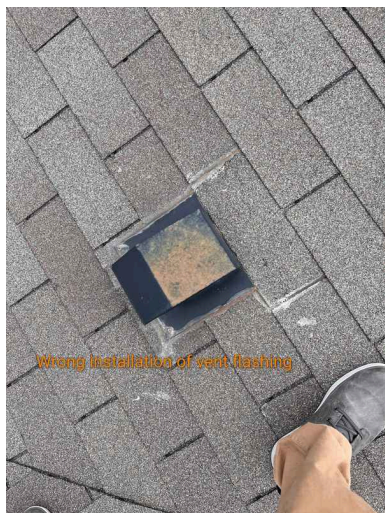
#### 4: Flashing Installation Deficiency

Improper roof flashing installation was observed during inspection. Flashing defects—including incorrect type, improper installation, or missing components —allow water infiltration at roof penetrations and transitions. This can lead to water damage, rot, mold growth, and structural deterioration.

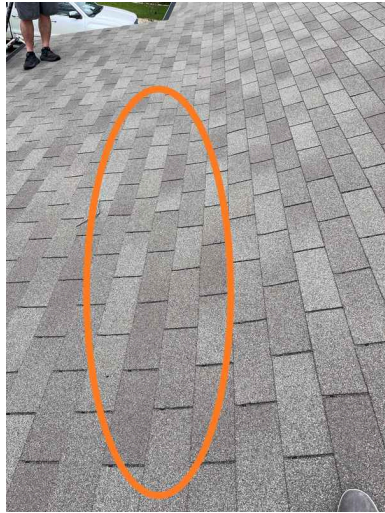
#### 5: Soft, Sagging Deck Area

Localized roof sheathing is soft, depressed, and sagging underfoot at the roof transition between the patio and main structure. This condition indicates deteriorated or rotted sheathing boards resulting from chronic moisture intrusion

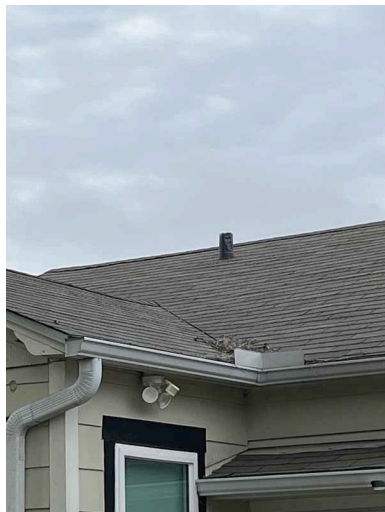
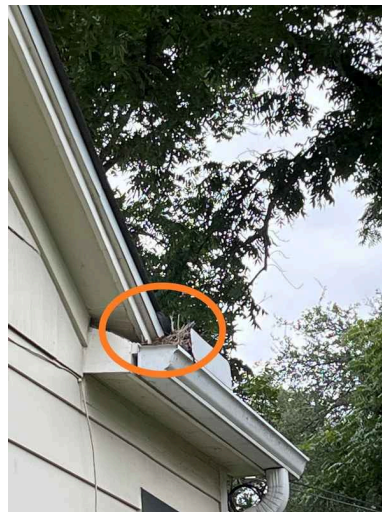
## 6: Debris Accumulation in Gutters and on Roof

Tree leaves were observed accumulated on the roof surface and inside the gutters during inspection. This debris prevents proper water drainage and can lead to water pooling, roof damage, and gutter deterioration over time. Regular cleaning of gutters and roof surfaces is necessary to maintain proper drainage and prevent moisture-related damage to the home's structure.

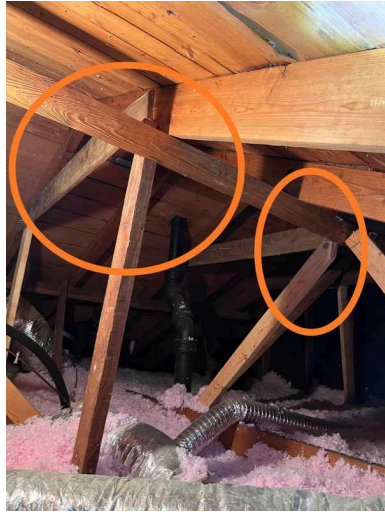
### 1: Roof Structural Deficiency

Rafter purlin bracing is undersized and mechanically loose. Purlin braces must match rafter depth and be firmly seated to provide required midpoint load transfer to bearing walls.

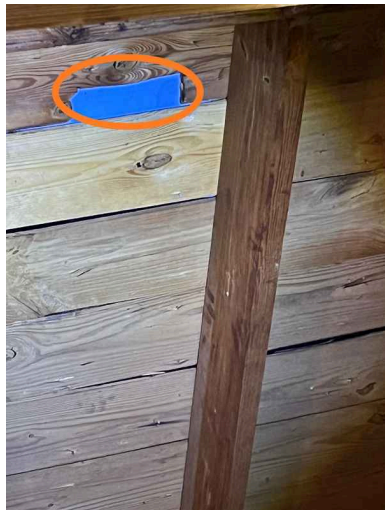
### 2: Sagging/Damaged Roof Deck

Damaged roof deck and noticeable deflection (sagging) was observed in the roof rafter framing and sheathing. Framing sag indicates undersized rafters, inadequate intermediate bracing, or compromised sheathing from prior leaks.

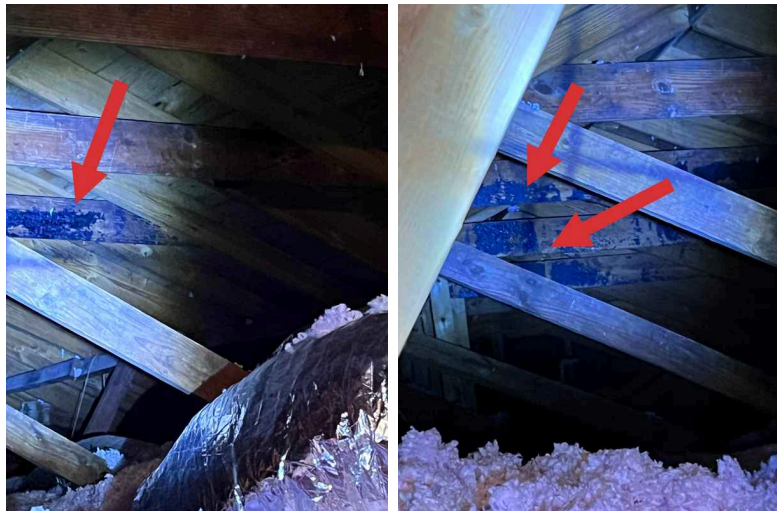
### 3: Evidence of Previous Water Penetration

Signs of past water intrusion and dried tar leakage were observed in the roof structure or attic area during inspection. Water stains, discoloration, or moisture damage indicate that water has penetrated the roof system at some point.

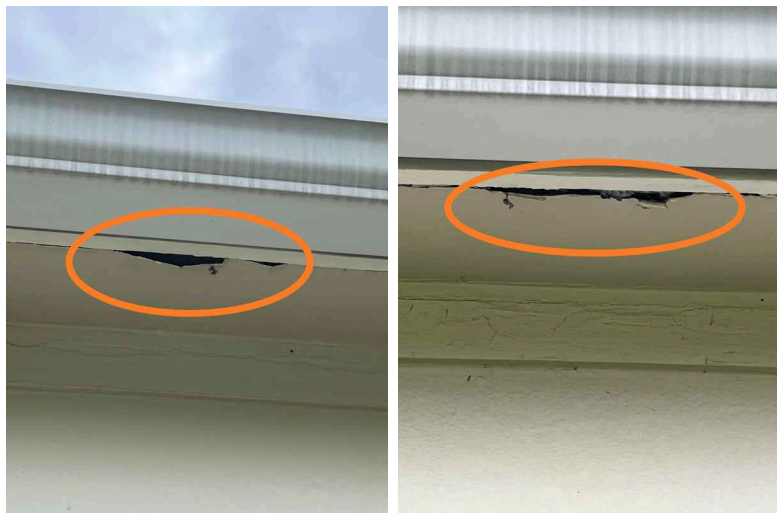
#### 4: Evidence of Previous Water Penetration

Paint peeling and water penetration were observed at the soffit. This indicates moisture is bypassing the protective paint coating and entering the soffit structure, which can lead to wood rot, structural deterioration, and potential interior water damage.

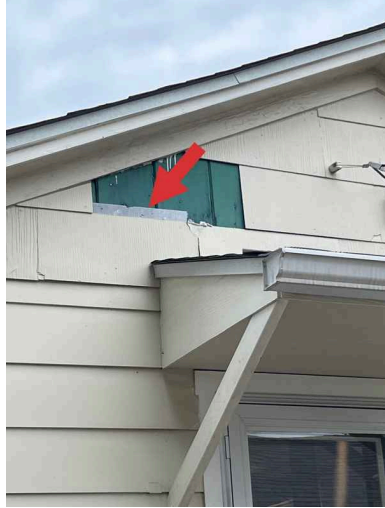
Siding board material exhibits physical characteristics consistent with asbestos, a hazardous substance commonly found in older building materials. The material should not be removed, repaired, or disturbed without professional assessment. Contact a qualified/licensed environmental professional to test the material and determine appropriate remediation or encapsulation options.

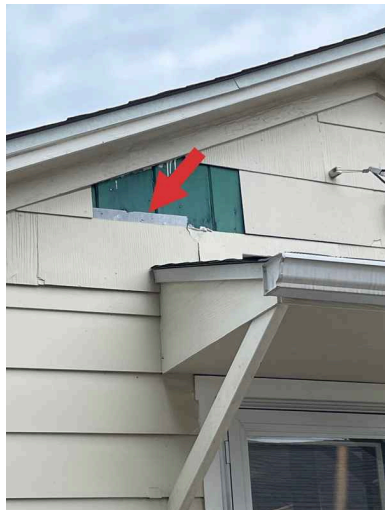
## 2: Missing or Damaged Siding Board

Exterior cladding has sections of missing siding, exposed underlayment, and widespread peeling/flaking paint. Unsealed wood and exposed substrates allow moisture penetration into the wall cavities, inviting concealed framing rot and insect entry.

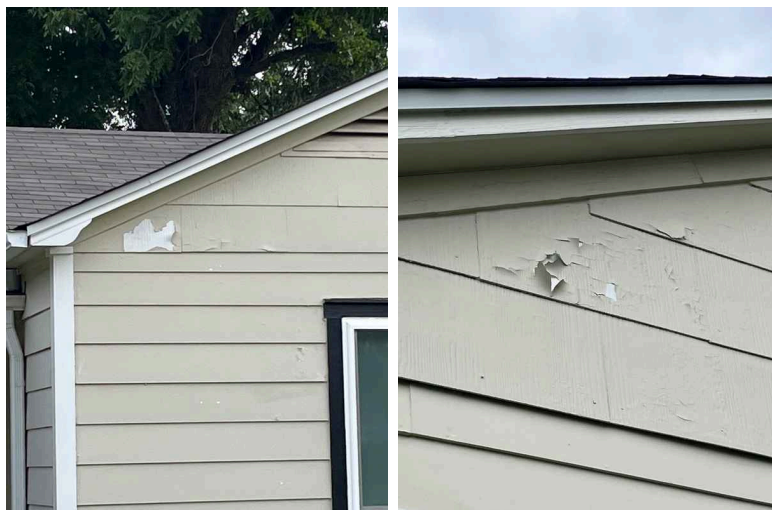
## 3: Peeling Paint on Exterior Wall

Peeling paint observed on the exterior wall during inspection. This indicates paint failure, which exposes underlying surfaces to moisture and weathering. Paint should be scraped, sanded, and repainted to protect the

wall surface from further deterioration.

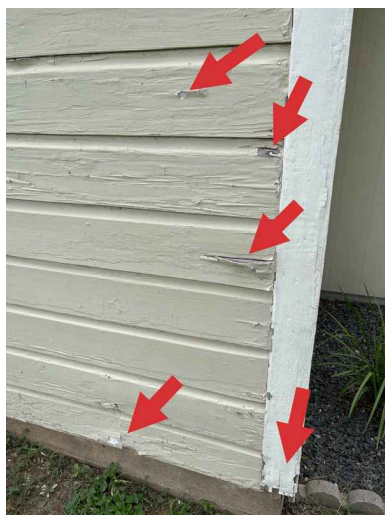
#### 4: Evidence of Water Intrusion

Peeling paint and water penetration was observed. Wall structure showed signs of water intrusion, which could lead to more serious structural damage.

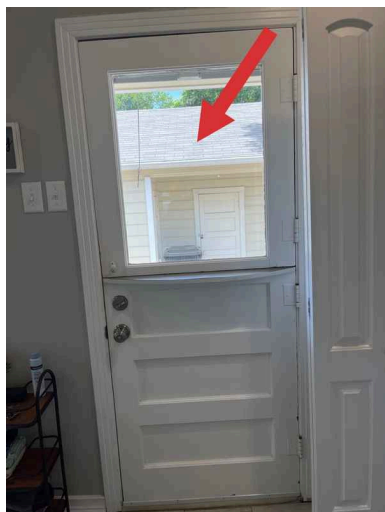
### 1: Missing Safety Glass

The exterior kitchen door features non-tempered, annealed glass panels. Glass installed within 24 inches of a door opening requires tempered safety glass to reduce the hazard of severe laceration upon accidental impact.

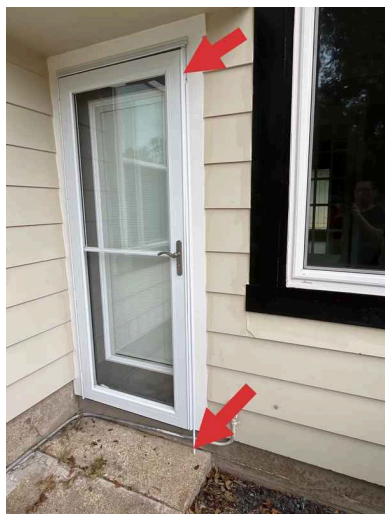
### 2: Improper Door Installation

The rear exterior door unit has loose framing members, gaps around the jamb, and unstable mounting. This allows drafts, water penetration, and compromised physical security.

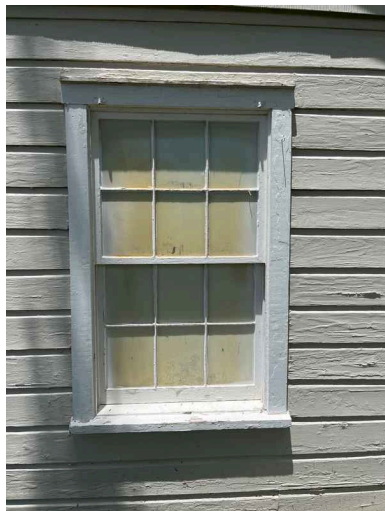
Window sashes are painted shut and cannot be opened. Windows must operate freely to allow ventilation and emergency egress where required.

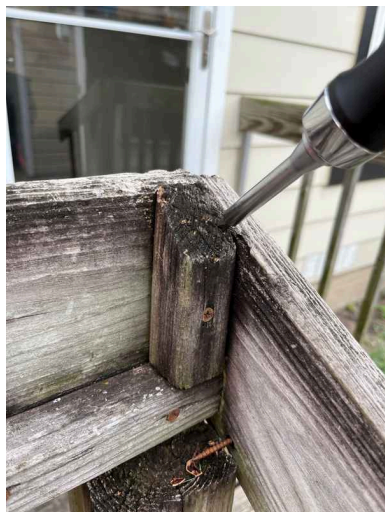
Surface deck boards exhibit localized wood rot, soft spots, and elevated nail/screw heads. Rotted boards create a structural failure risk and trip hazard.

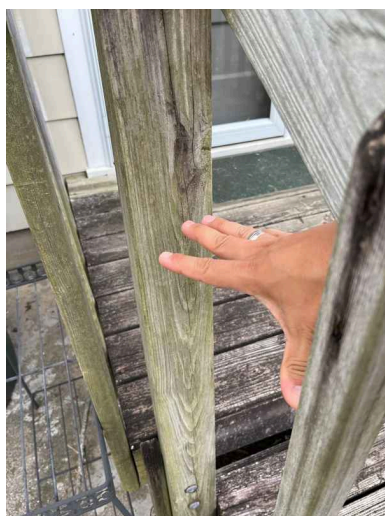
## 2: Baluster Openings Exceed Safety Standard

Baluster openings measured greater than 4 inches, which exceeds the safety standard for preventing child fall and entrapment. Openings of this size pose a significant safety hazard, as a child's head or body could become trapped between balusters. Balusters should be modified or replaced to ensure spacing does not exceed 4 inches.

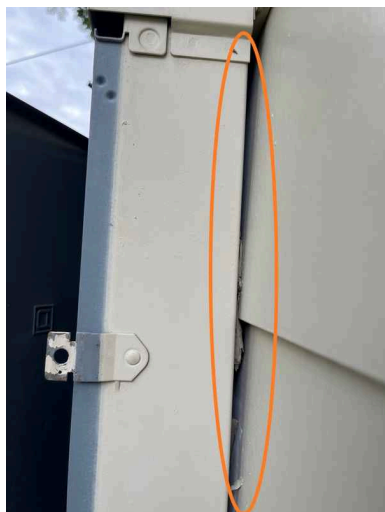
Main disconnect/service panel box is not properly caulked or sealed, allowing debris accumulation between the disconnect and siding. This creates potential for water and moisture infiltration, which could compromise electrical safety and accelerate corrosion of components.

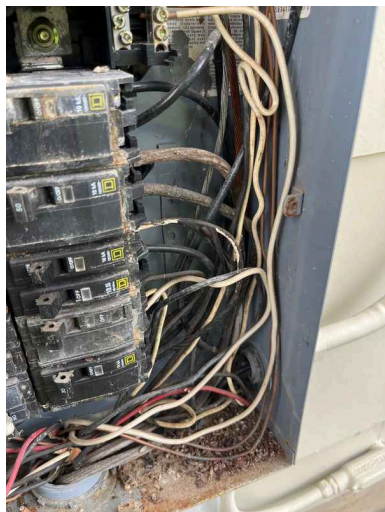
#### 2: Panel Damaged

The exterior main disconnect service panel box shows substantial surface rust, paint peeling, and metal degradation. Enclosure degradation compromises weather protection for internal live electrical components.

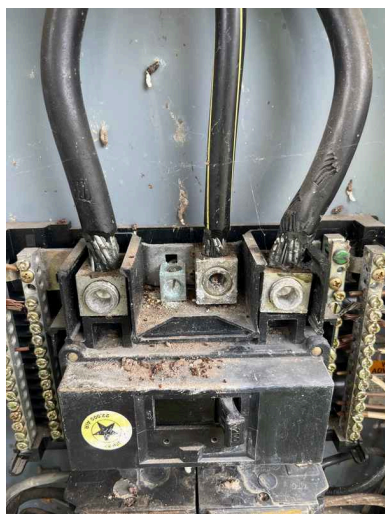
### 3: Corroded Conductor Terminal

Corrosion and oxidation observed on the conductor terminal in the electrical service entrance. Corroded connections generate elevated electrical resistance, causing overheating, arcing, and potential panel fire.

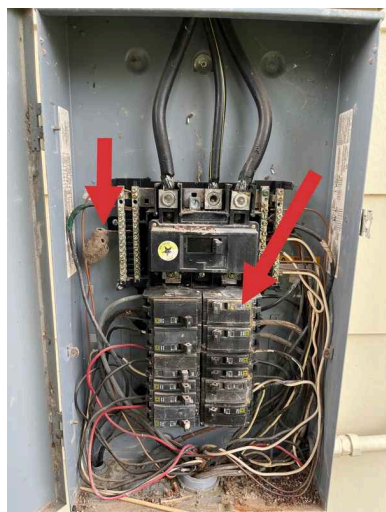
### 4: Improper Breakers and Animal Ingress

Improper breakers were installed in the electrical panel, and signs of animal/insect ingress were observed. Improper breakers create fire and shock hazards and may not provide adequate circuit protection. Animal/insect presence in the panel indicates compromised system integrity and potential safety hazards.

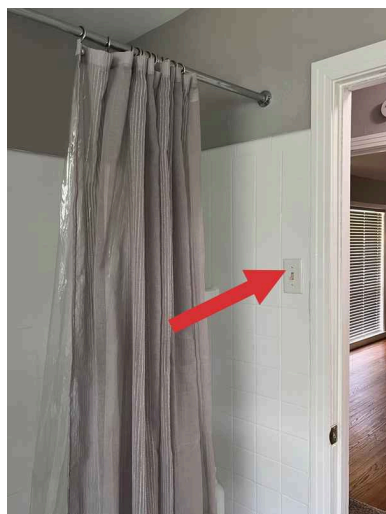
A standard toggle switch is installed within reach of the tub/shower basin. Operating a standard switch in a damp or wet zone increases the risk of shock. Recommend a licensed electrician evaluate and either relocate the switch or verify/install GFCI protection on the circuit.

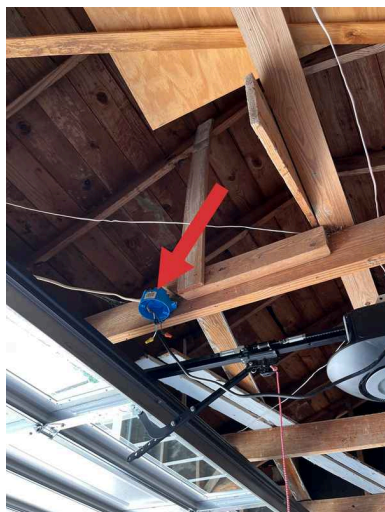
An uncovered junction box with exposed electrical wire splices was observed in close proximity to the garage door track. Open splices present an immediate shock and electrocution hazard and risk mechanical damage from door operation.

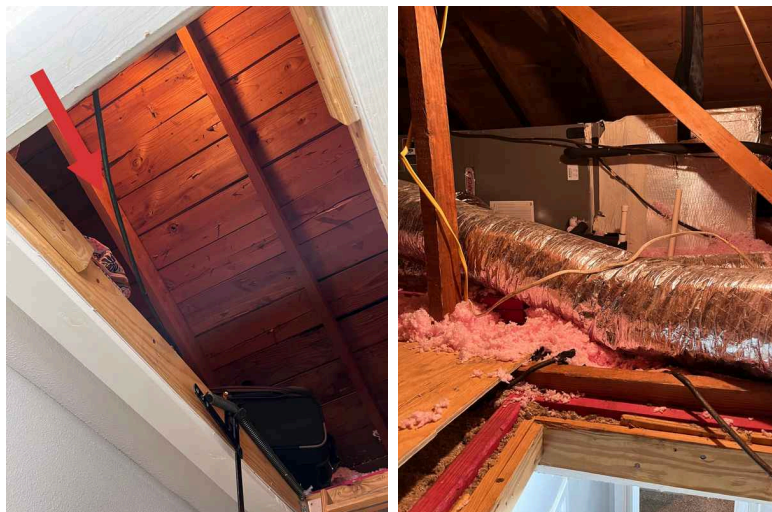
### 5: Unprotected Wiring In Attic

Non-metallic (NM) cable is run loose across attic joists within 6 feet of the attic access hatch without protective guard strips or conduit, and is buried beneath loose insulation. Unprotected wiring near access hatches is vulnerable to foot traffic damage, crushing, and physical abrasion.

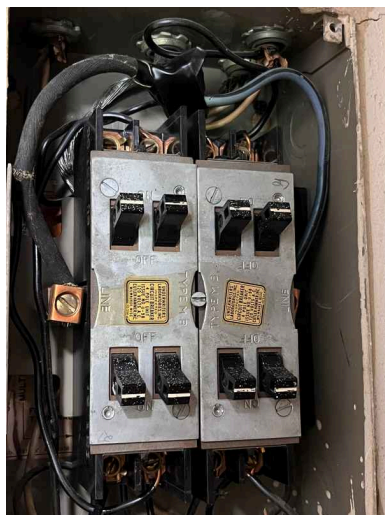
## 6: Insufficient Clearance

An electrical subpanel is located inside a clothes closet, lacking the required clear working space (minimum 30 inches wide by 36 inches deep). Panels are strictly prohibited in clothes closets due to the ignition risk of hanging fabrics and obstructed emergency access.

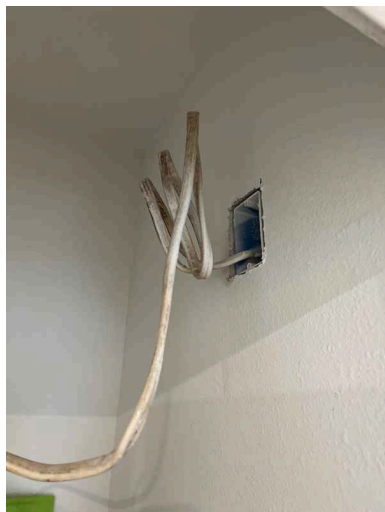
## 7: Uncovered Junction Box

Open junction box observed. Recommend concealing or replacing.

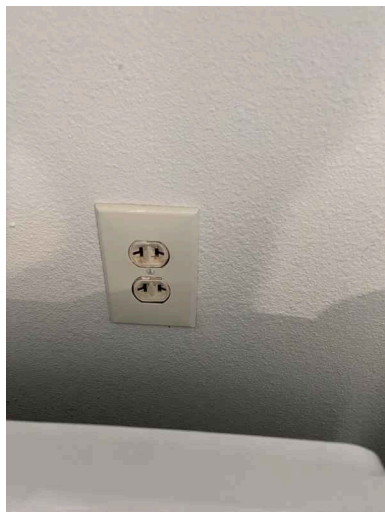
Ungrounded outlets lack a third prong connection and do not provide ground fault protection. Modern electrical standards recommend updating wiring to grounded circuits or installing GFCI (Ground Fault Circuit Interrupter) protection to reduce shock and fire hazards, particularly in wet areas and for high-powered appliances.

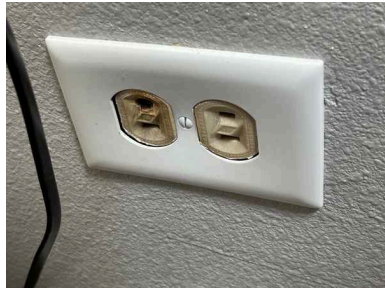
### 10: Damaged / Scorched Receptacle

Evidence of previous overheating or burn marks observed at an outlet, conductor, or terminal during inspection. This indicates the electrical connection experienced excessive heat, which can result from loose connections, overloaded circuits, or arcing. Overheating poses a fire hazard and suggests the affected connection requires professional evaluation and repair to ensure safe operation.

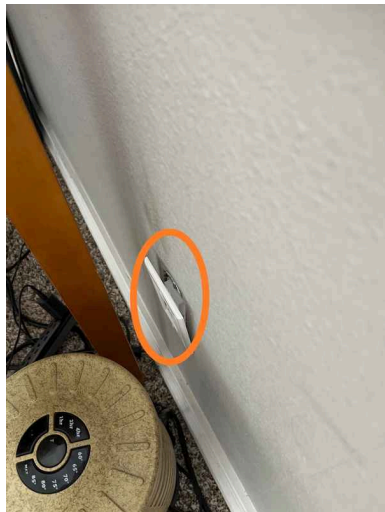
### 11: Loose Receptacle

An electrical outlet in the living room is hanging loose from the junction box. Loose receptacle connections generate excessive heat, arcing, and an imminent fire hazard.

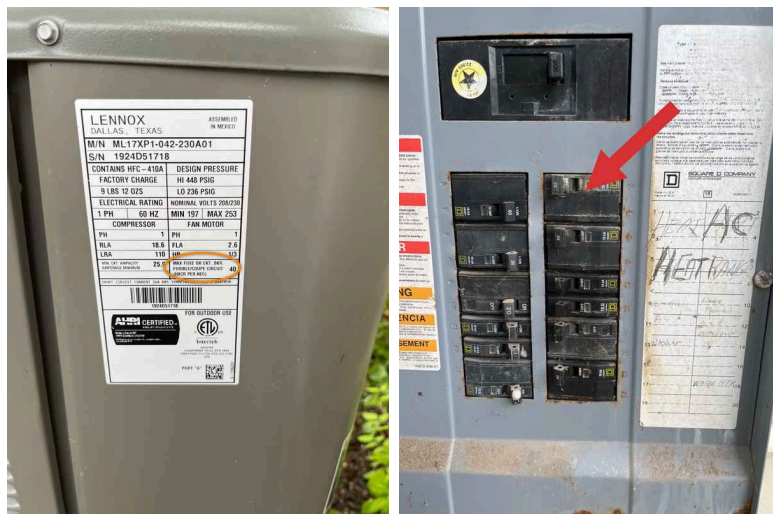
The Lennox outdoor heat pump nameplate specifies a Maximum Overcurrent Protection Device (MOPD) of 40 Amps (Minimum Circuit Ampacity: 24.3A). The unit is currently connected to a 50-Amp circuit breaker in the service panel. An oversized breaker will fail to trip during compressor locked-rotor conditions, creating an acute equipment burn-out and fire hazard.

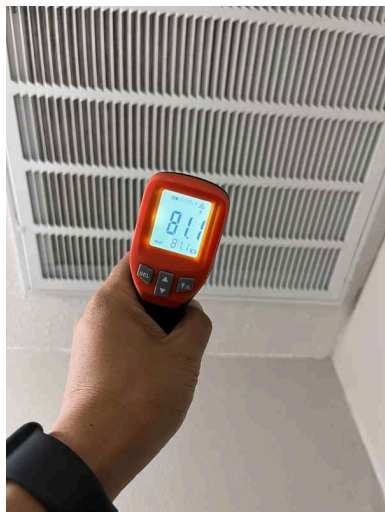
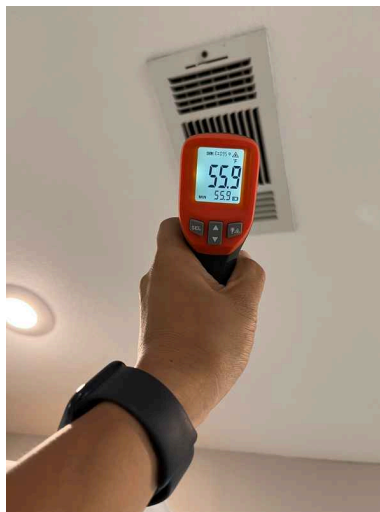
### 2: Air Conditioning Temperature Differential Out of Range

The cooling system recorded a temperature differential (Delta T) of 25°F between return air (81°F) and supply air (56°F). Standard cooling differential ranges between 15°F and 22°F. An elevated split indicates restricted airflow across the indoor evaporator coil (e.g., severely clogged air filter, dirty coil, or incorrect blower speed setting), which strains the compressor and risks evaporator coil freeze-up.

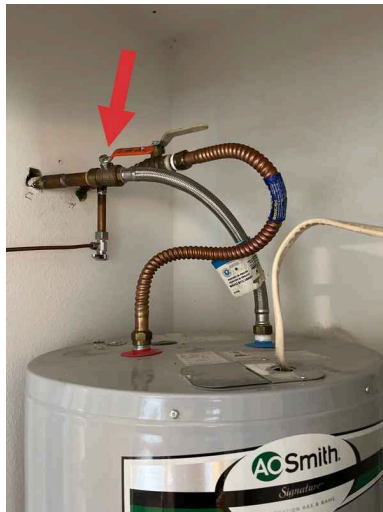
An unapproved isolation shut-off valve is installed on the hot water outlet pipe directly exiting the water heater. Closing a valve on the hot water distribution line can trap expanding heated water and interfere with proper temperature-pressure relief, creating a dangerous system over-pressurization risk.

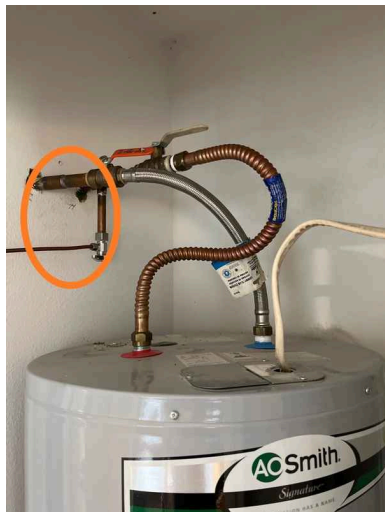
**3: Cross Contamination Hazard - Ice Maker Water Line**

Ice maker line is tapped directly into the cold supply pipe, creating a cross contamination hazard. These connections lack proper backflow protection and are prone to leakage over time.

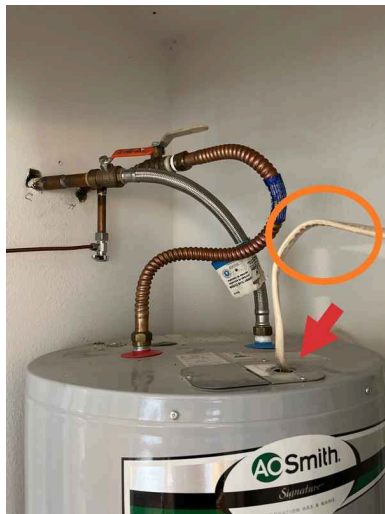
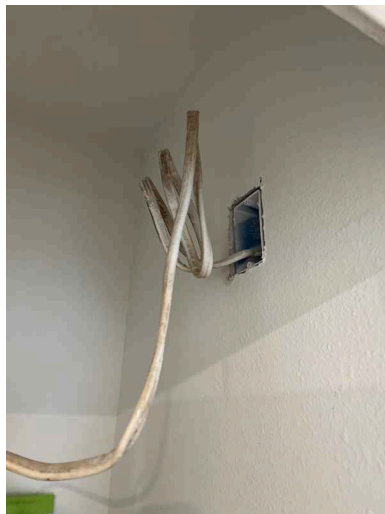
#### 4: Unprotected Electrical Wire and Missing Electrical Box Cover

Non-Metallic (NM) cable entering the water heater top knockout lacks an approved cable clamp connector and conduit protection, and the wiring junction cover is missing. Bare conductors entering sharp knockout edges risk insulation chafing, short circuits, and occupant electrical shock.

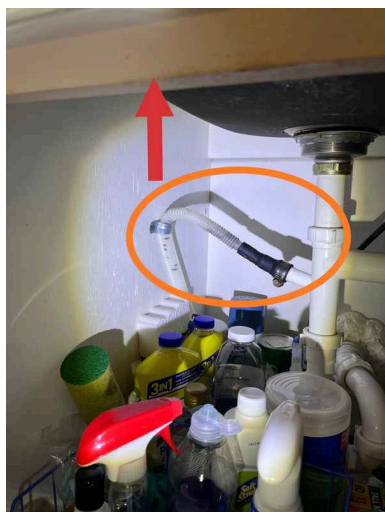
The dishwasher's high loop is not installed at a sufficient elevation anchored to the underside of the countertop. A high loop or air gap is necessary to prevent wastewater from siphoning back into the dishwasher, which can contaminate the fresh water supply and cause operational issues.

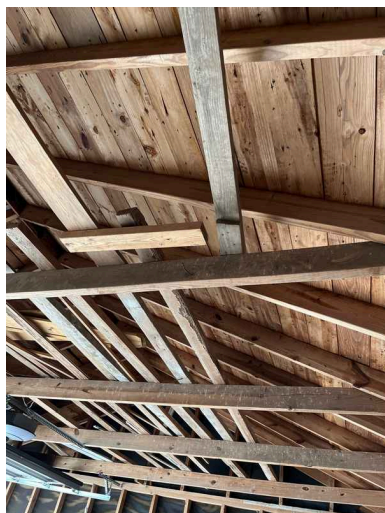
Loose, unfastened lumber boards are resting across unfinished ceiling framing. These boards present an acute impact and fall hazard to occupants below.

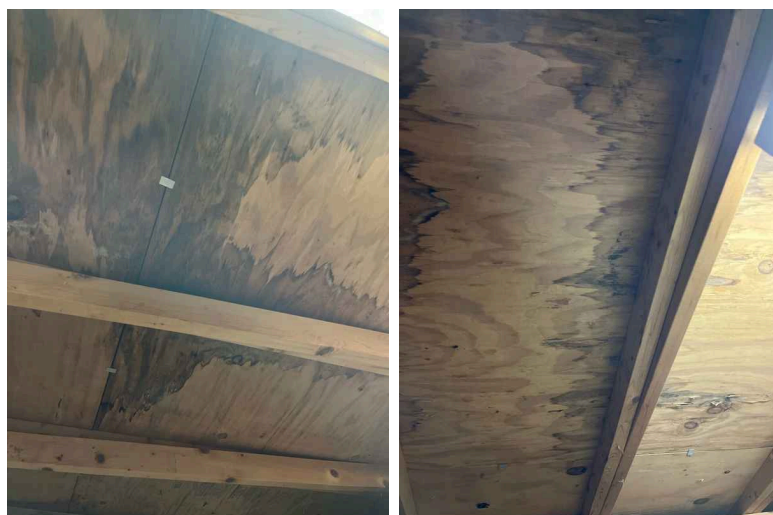
### 3: Previous Water Penetration Signs

Signs of previous water penetration observed at the shed ceiling during inspection. This indicates past moisture exposure that may have caused or could cause structural damage, rot, or mold growth if the source is not identified and corrected.

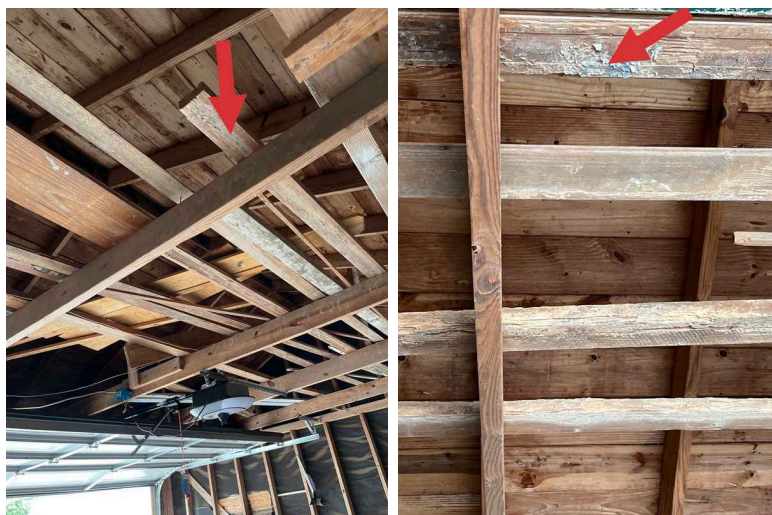
## 5: Potential Pest Infestation

Evident insect galleries, channeling, and wood deterioration consistent with wood-destroying insect activity were observed in the exposed ceiling joists and framing. A licensed Wood Destroying Insect (WDI) inspector should evaluate the extent and type of infestation to determine appropriate treatment.
